DEPARTMENT OF TRANSPORTATION**DIVISION OF ENGINEERING SERVICES**

Quality Assurance and Source Inspection

Contract #: 04-0120F4Cty: SF/ALA Rte: 80 PM: 13.2/13.9File #: 1.28**WELDING INSPECTION REPORT****Resident Engineer:** Casey, William**Address:** 333 Burma Road**City:** Oakland, CA 94607**Report No:** WIR-026812**Date Inspected:** 03-Dec-2011**Project Name:** SAS Superstructure**OSM Arrival Time:** 700**Prime Contractor:** American Bridge/Fluor Enterprises, a JV**OSM Departure Time:** 1530**Contractor:** American Bridge/Fluor Enterprises, a JV**Location:** Job Site

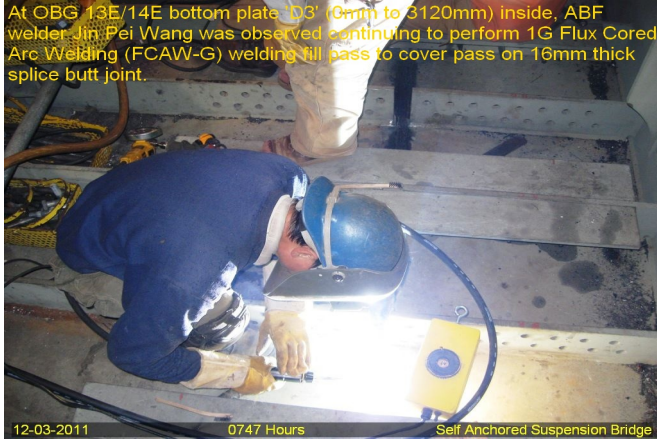
12-03-2011 0747 Hours Self Anchored Suspension Bridge

At OBG 13E/14E bottom plate 'D3' (0mm to 3120mm) inside, ABF welder Jin Pei Wang was observed continuing to perform 1G Flux Cored Arc Welding (FCAW-G) welding fill pass to cover pass on 16mm thick splice butt joint.

QA randomly observed ABF/JV qualified welder Join Pei Wang continuing to perform Complete Joint Penetration (CJP) groove welding fill pass on Orthotropic Box Girder (OBG) 13E/14E bottom plate 'D3' (0mm to 3120mm) inside. The welder was observed manually welding in the 1G (flat) position utilizing a dual shield Flux Cored Arc Welding (FCAW-G) with E71T-1M, 1/16" diameter wire electrode and implementing Caltrans approved Welding Procedure Specification (WPS) ABF-WPS-D15-3040A-1. The 16mm plate thick splice joint has a single V-groove design. The splice joint was continuously preheated to greater than 150 degrees Fahrenheit using Miller Proheat 35 Induction Heating System with the heater blankets located at the bottom of the plate being welded. During welding, ABF Quality Control (QC) Fred Von Hoff was noted monitoring the welding parameters of the welder. Measured welding parameters during welding were 255 amperes, 24.5 volts which appears in compliance to the contract requirements. During the shift fellow QA Craig Hager took over the observations on this welding work.

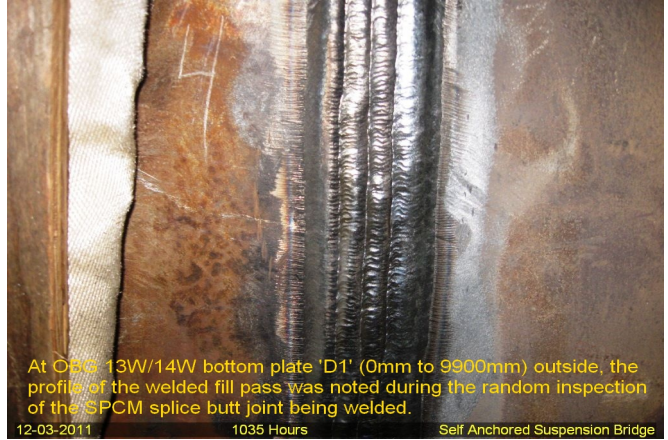
12-03-2011 1035 Hours Self Anchored Suspension Bridge

At OBG 13W/14W bottom plate 'D1' (0mm to 9900mm) outside, the profile of the welded fill pass was noted during the random inspection of the SPCM splice butt joint being welded.

QA randomly observed ABF/JV qualified welders Rory Hogan (ID #3186) and Jeremy Dolman (ID #5042) perform CJP groove (splice) back welding fill pass on a 30mm/35mm unequal thickness Orthotropic Box Girder (OBG) 13W/14W bottom plate 'D1' (0mm to 9900mm). The welders were observed welding in the 4G (overhead) position utilizing a dual shield Flux Cored Arc Welding (FCAW-G) with E71T-1M, 1/16" diameter wire electrode and implementing Caltrans approved Welding Procedure Specification (WPS) ABF-WPS-D15-3110-4. The welders were using a track mounted welder holder assembly that is remotely controlled. The Seismic Performance Critical Member (SPCM) splice joint being welded has the backing bar gouged using the Esab Plasma Arc machine and was ground smooth. The splice joint was continuously preheated to greater than 200 degree Fahrenheit using Miller Proheat 35 Induction Heating System with the heater blanket on top of the weld prior welding and moving the same heater blanket to the side of the weld during welding. The vicinity of the welding area was properly protected from wind. During welding, ABF Quality Control (QC) Steve Jensen was noted monitoring the welding parameters of the welder. The parameter readings taken during welding were 250 amperes, 23.1 volts with travel speed of 165 mm per minute and calculated heat input of 2.1 Kjoules per mm which are deemed acceptable to contract specifications. During welding, an approximately 600mm long of the fill pass was noted with porosity due to shielding gas problem. The welders have resolved the shielding gas issue and removed the porosity then resumed welding. At the end of the shift, FCAW-G fill pass welding was still continuing and should remain Monday.
